AMERICAN PRECISION MUSEUM
196 MAIN ST. PO BOX 679 WINDSOR VT 05089

PRESERVATION BULLETIN

VOLUME 1, ISSUE 2 JUNE 2004

Repair or replace? Building Committee Chair Robert Pantel organized a roof examination March 1, 2004, to answer the big roof question. The roof was clear of snow and the fine weather provided ideal viewing of the roof's most serious problems. Chair Clark Griffiths, trustee Hub Yonkers, architect Tom Keefe, staff John Alexander and Ann Lawless, took turns going up in the bucket with roofer Bill Hughes, Melanson Co. The elevation and distant vistas were heady. The views up close were discouraging but conclusive. The Executive Committee made the replacement of the roof its #1 preservation priority.

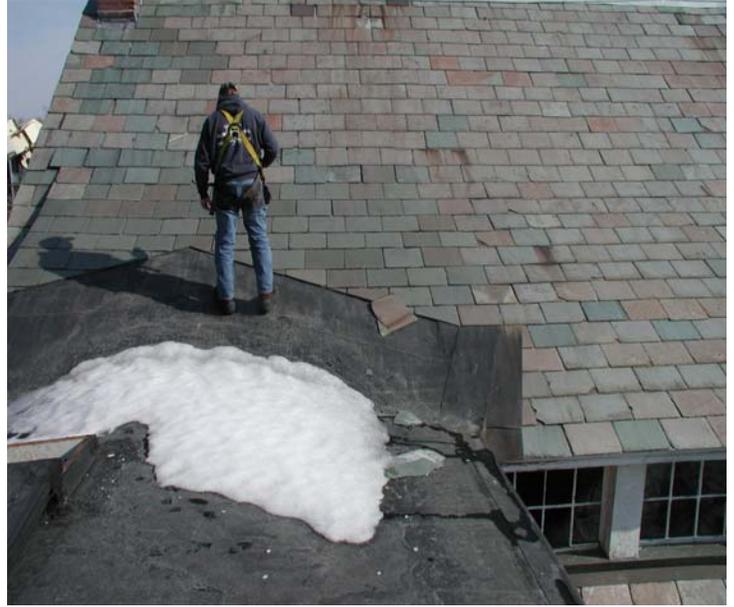
Slates no longer secured because of failing nails have slid down the roof and rest on the tower flashing. More lie to the right of the snow bank.

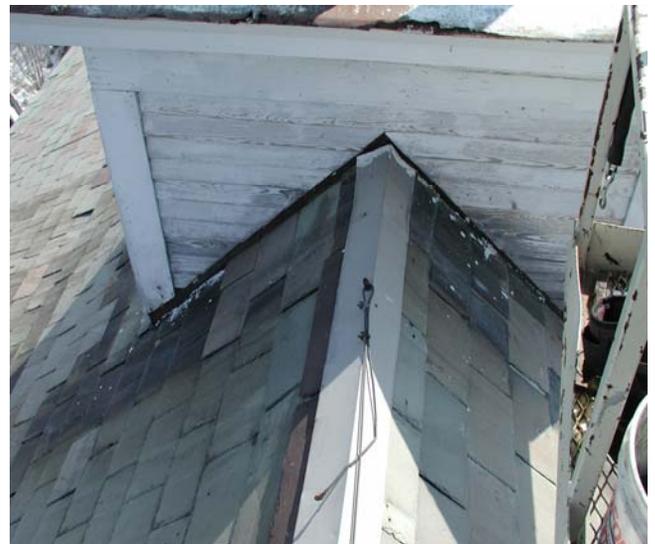
F **lashings** are sheet metal joints to prevent water entry between the various planes of the roof, such as in the valleys, along dormer walls, around chimneys. The most common older flashings were made of terne-coated steel—steel coated with a lead/tin combination, erroneously but commonly called "tin". Terne-coated steel must be painted regularly. Copper and lead-coated copper are durable, easily worked and require little maintenance. The use of dissimilar flashing metals and fasteners on the Armory roof has led to corrosion by galvanic action.

Metals used for flashing the roof cap, dormer and cupola sides must all be compatible metals—along with the nails.

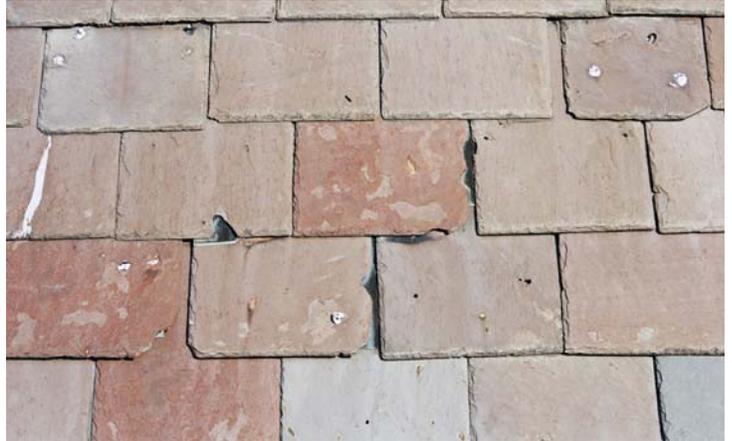
Nails. Slate is typically attached to wooden sheathing with two nails driven through prepunched holes. Slate nails are not driven tight, but set so that the slate hangs freely on the nail shank. Nails driven too far will crack the slate and those left projecting will puncture the overlying slate. Slater's nails of bronze, copper or stainless steel are now used since plain steel and galvanized nails rust out long before the slate itself begins to deteriorate. Rusting of the Armory roof's 19th Century cut nails has caused slate loss. Nail heads left exposed accelerate roof deterioration by providing a way for water entry. Nails are rotating and bending as the sheathing deteriorates. Applying roofing sealants to exposed nails or nail holes is not viable because these materials, though effective at first, will eventually harden and crack, thereby allowing water to enter. Some react to ultra-violet radiation and deteriorate quickly.

Popped nails have worn holes from the underside into and right through the slates above them. Nail holes and cracks have been unsuccessfully treated with sealant.

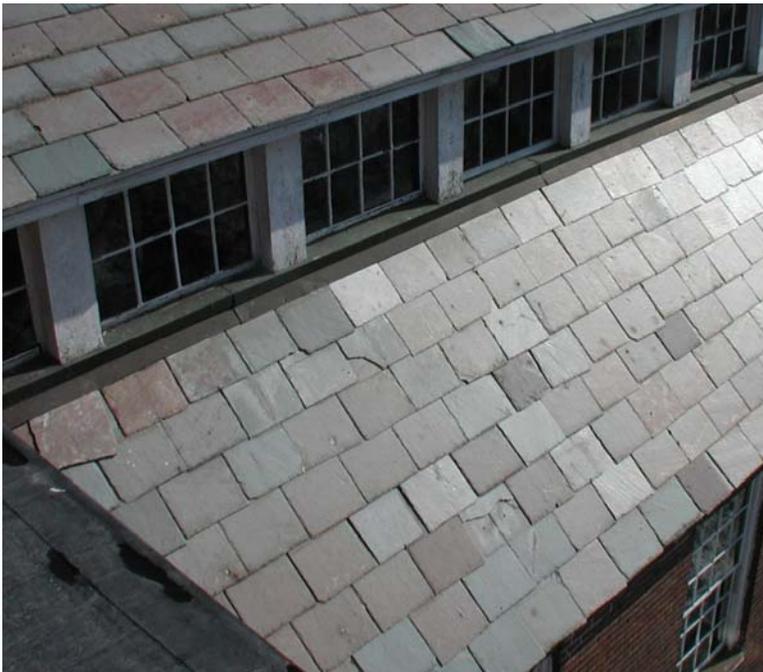
W **eathering.** The natural weathering of roofing slate is a slow process of chipping and scaling along the cleavage planes. Paper thin laminations flake off the surface and the slate becomes soft and spongy as the inner layers begin to delaminate. This process is chiefly due to mineral impurities (primarily calcite and iron sulfides) in the slate which react to form gypsum and rust. Because gypsum molecules take up about twice as much volume as calcite molecules, internal stresses cause the slate to delaminate. Ice causes the same effect. These chemical and physical changes cause an increase in absorption and a decrease in both strength and toughness. The tendency of old, weathered slates to absorb and hold moisture can lead to rot in underlying areas of wood sheathing. Weathered slates are more prone to breakage, loss of corners, cracking and slipping.

Sheathing. In 1846 the Armory roof consisted of wood shingles over board sheathing. Ca 1880 when the slate was installed, two layers of wood shingles were left in place underneath. Moisture increasingly held in this relatively thick, now spongy underlayer prevents the nails from holding the slates firmly and prevents the slates from being evenly supported. Many slates have slipped.

Weathered, loose, cracked and slipped slates.
