AMERICAN PRECISION MUSEUM PO Box 679 196 Main St. Windsor VT

PRESERVATION BULLETIN

A SPECIAL "THANK YOU " REPORT to our Phase I roof and windows project funders

WINDOWS RESTORATION UNDERWAY

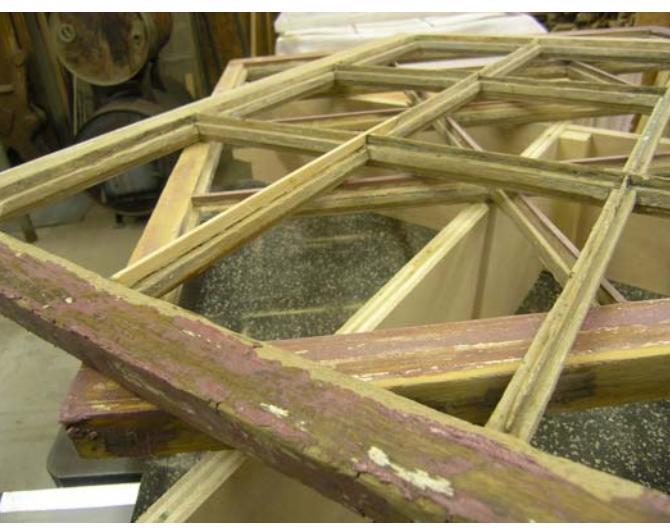
and Wesner Architects, In the shop—window sash with glass carefully removed, paint P.C. reported favorably dipped away, ready for wood and epoxy repairs.

of experience molding and shaping odd parts). He has fitted pieces of wood where muntins need an armature for epoxy, and tightened the pegged stiles and rails in true alignment. He is applying a thinned 4-coat paint finish that is smooth and has full coverage of all parts. He also dips the glass, all of which is removed using copper heat diffusion plates to avoid breakage while effectively softening the old putty to allow complete removal. All old putty is

removed from the glass, and it can then be reinstalled. The result is a "like-new" sash with all the original muntin profiles and pegged frame details. I'm very pleased with his approach and the quality of the work."

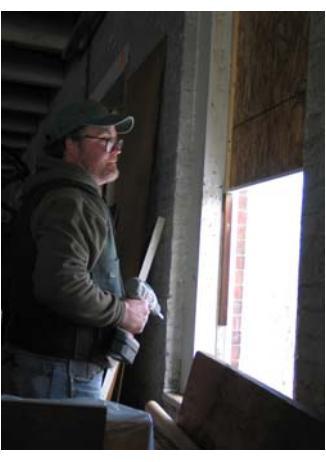
Jim Hunt returned to the museum in early February to remove the second batch of sash. Here he is protecting the window openings with plywood.

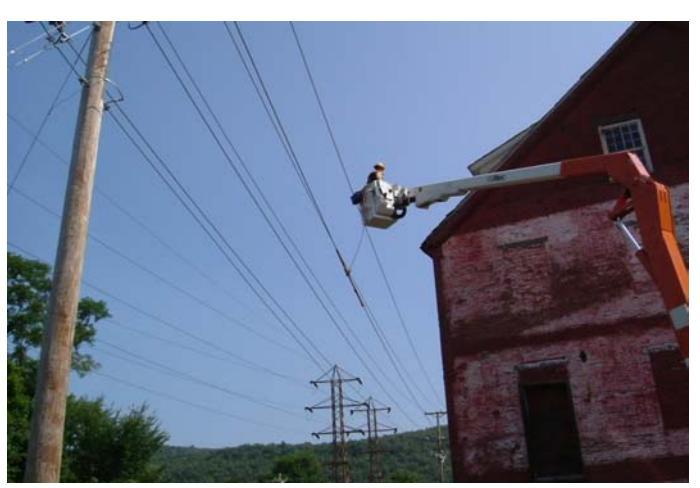
Wires from the CVPS substation behind the Armory that pass too close to the building must be moved to make it safe for the roof and windows project.

electric wires Loaded from the Central Vermont Public Service substation located behind the building pass extremely close to the northwest cornertoo close, in fact, for the safety of people working on the scaffold. CVPS will move the wires before the scaffolding is positioned, and will move the wires back after, adding \$6,500 to the project.

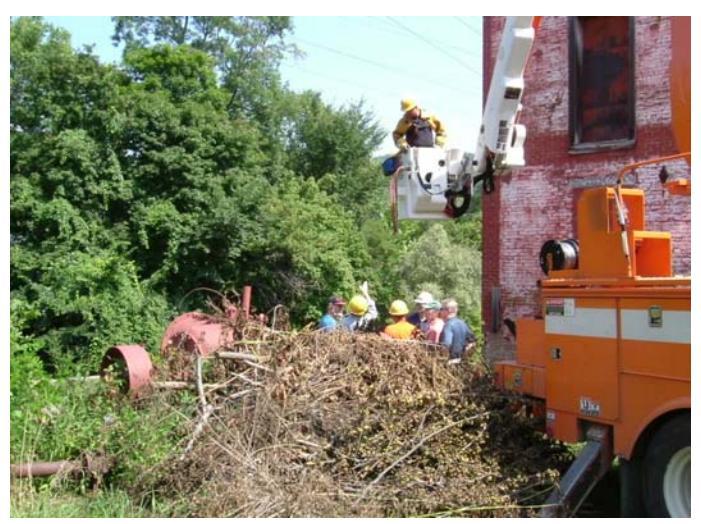
In July 04, CVPS brought a lift truck to examine the wire situation up close, with museum trustees, staff, architect Keefe and representatives from the Melanson Co., who have been awarded the roofing contract.

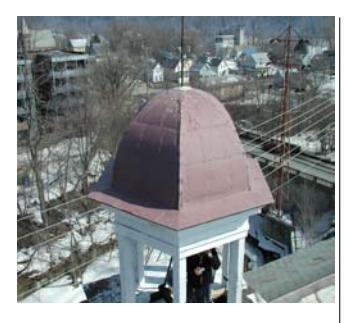
Cupola framing and trim repairs and a new bell deck are needed.

Architect Keefe is under contract to develop a scope of work and budget to address the structural issues and the needed cupola repairs. His analytical process will be made easier by the scaffolding that will soon be in place for the roof work. Window specifications already developed in 2004 for Phase I will be useful in planning the budget for the remaining 90 windows.

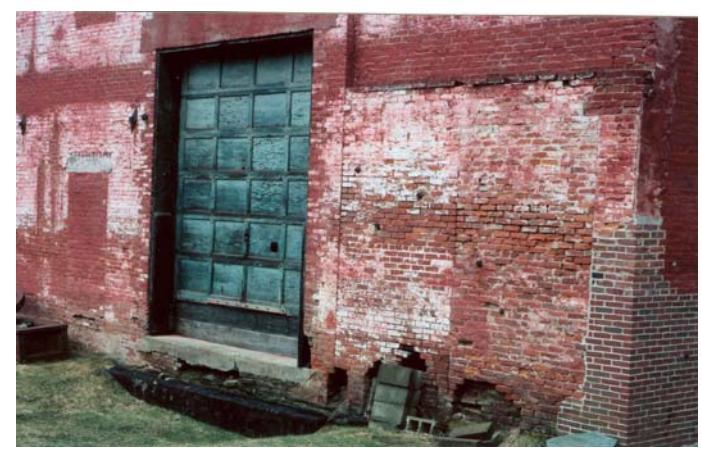
The west wall shows deteriorated mortar, poorly matched brick infill and areas of missing brick.

The Armory was built in 1846. Many repairs to the brick and its original, soft, mortar were made over the years.

Portland cement mortars, harder than the old handmade brick, were used extensively on all areas of the building exterior. This mortar is too hard to act as a cushion for

the brick. This inappropriate infill needs to be removed and replaced with a softer mortar compatible with the old brick. Professional coldclimate masonry restoration specialists helped us develop a competitive budget for the masonry planning project. The outcome will be a budget and scope of work for the restoration. The planning will entail onsite investigations and lab analysis.
